Source: *APT Bulletin*, Vol. 23, No. 4, Historic Structures in Contemporary Atmospheres (1991), pp. 37-42

Influence of Microclimate on the Deterioration Of Historic Marble Buildings

ELAINE S. McGEE

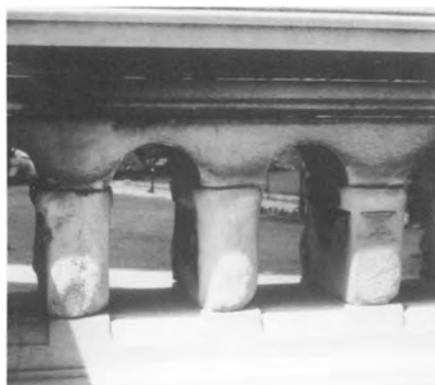
Fig. 1. Rounded edges are left by dissolution. Balustrade, U.S. Capitol, Washington, D.C

Dissolution of marble may be manifested in several ways on a building. The original, smooth surface finish may be lost when dissolution occurs around the edges of individual grains of calcite in the stone; this is commonly called sugaring because of the way the surface texture appears after lengthy exposure. Minerals in addition to calcite (known as inclusions) may weather preferentially, resulting in grooves or pock marks where the inclusions became loosened and fell out when the surrounding calcite dissolved. In other cases inclusions are more resistant than the calcite, protruding above the dissolved calcite surface. Sharp edges and carved details may become rounded (Fig. 1) as the exposed parts of the stone are dissolved by rainfall or dripping water. In some exposed areas, catastrophic loss may occur; large chunks or whole architectural details may be missing. Although dissolution may have been a major contributor, other

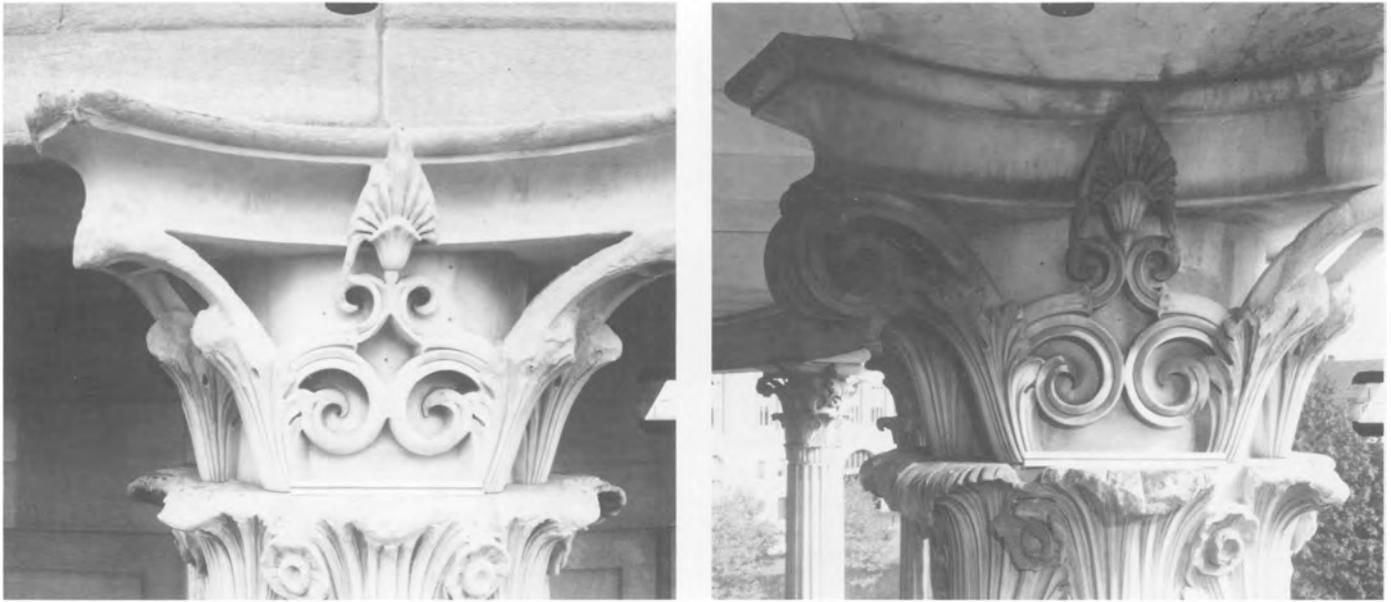
Figs. 2 a,b. Exposed volute on the column capital, *left*, is almost completely gone but the sheltered portion, *right*, still retains intricately carved details. Merchants' Exchange, Philadelphia, Pa.

All examples of deterioration of marble from dissolution are located where the stone has been exposed to washing by rainfall or to water flowing over the stone. Where stone is protected from direct washing, it has dissolved by the acidic water. The Corinthian capital in Fig. 2 shows the striking difference in deterioration that can occur between an area exposed to rain and one that is sheltered.

the carvings, that correlate with exposure and position on the building. Most carved features of the capitals are retained where the stone is sheltered from direct exposure to rain, but have lost definition when exposed to rain (Fig. 2). Capitals on the west facade all retain their exterior volutes (with no evidence of repair) (Fig. 9), but the outside volutes have been lost more or less completely on the east capitals (Fig. 10). As with the dentils, there are slight differences in the deterioration of capitals on the north and south sides of the east facade. The carved features on the exposed portion of the south capitals are much more worn (e.g., eroded and broken off) than on the counterpart north capitals. In particular, the details are lost or rounded on the south capitals. It is more difficult to make visual comparisons of differences in crust thickness, but close examination suggests a slightly thicker crust on the north capitals compared with the south capitals.

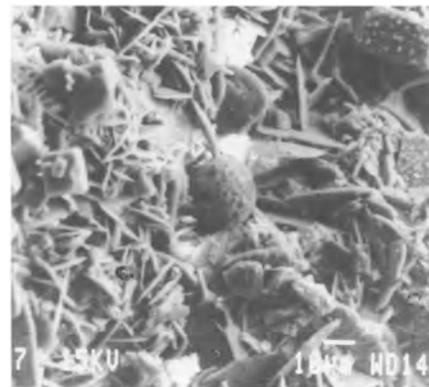
Fig. 3. Network of bladed gypsum crystals on marble traps particles to form the blackened alteration crust on marble; scale is 10 micrometers.

dioxide, it accumulates in areas that are protected from washing by rain. Gypsum crystallizes as a network of bladed grains covering the surface. Although gypsum is a white to colorless mineral, with time the network of bladed crystals readily traps dirt and pollutants (Fig. 3), causing the crust to appear black. Blackened crusts can become quite thick in older buildings; underneath the crusts, the marble may be disaggregated by penetration of solutions that dissolve the calcite or by growth of new gypsum crystals between the calcite grains (Fig. 4). When the crusts are removed, the stone underneath is likely to be even more vulnerable to further attack and degradation because of its greater surface area and the greater accessibility to water penetration afforded by the grain disaggregation.

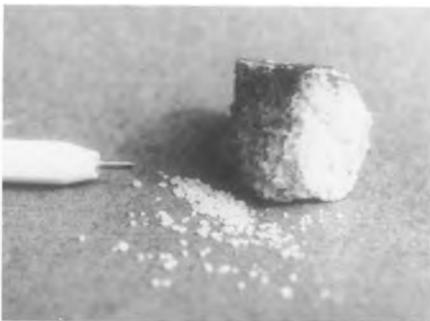
Figs. 4 a,b. The marble is badly disaggregated underneath the 0.8 mm thick blackened crust from the 160-year-old Merchants' Exchange, Philadelphia, Pa., as shown in this sample and detail at 1 mm scale.

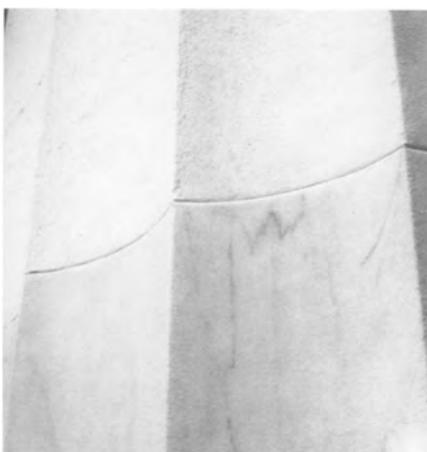
Fig. 6. One block of Colorado marble has sugared after about 70 years exposure, but an adjacent block of the same marble has been more resistant to weathering. Lincoln Memorial, Washington, D.C.

change Building in Philadelphia with identical exposure to climatic conditions show a visible difference in surface roughness (Fig. 5). Some marbles are so inhomogeneous that stone taken from different parts of the same quarry may vary greatly in its resistance to weathering. At the Lincoln Memorial in Washington, D.C., adjacent blocks of Colorado Yule marble with identical exposure have weathered quite differently (Fig. 6).

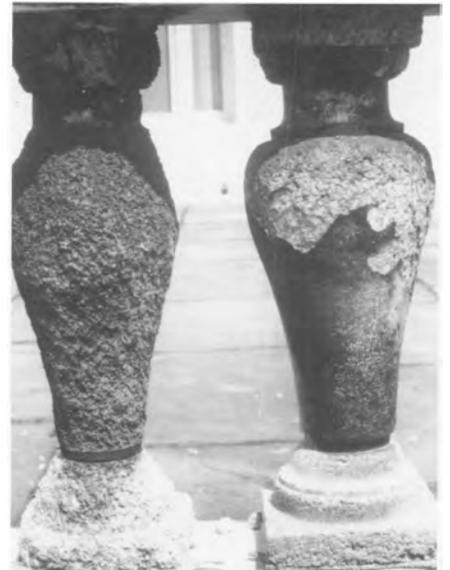
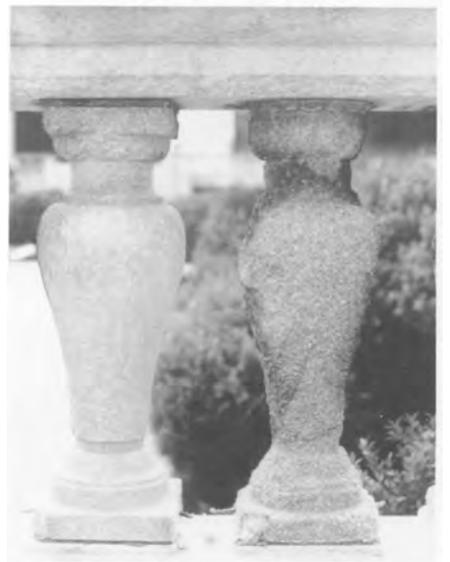
Figs. 7 a,b. The marble balusters facing the garden, *top*, are covered by a blackened alteration crust. The reverse sides, *bottom*, (facing a patio) show very little surficial alteration. Marble balusters at the Organization of American States Building, Washington, D.C.

Some significant variations in stone deterioration are not attributable to stone characteristics however. For example, marble balusters behind the 80-year-old Organization of American States building in Washington, D.C., are blackened and blistered where they face a garden but are only slightly deteriorated where they face a patio (Fig. 7).

This difference must be due to small-scale differences in exposure; the nearby bushes may shield the balusters from rainfall, or the balusters may be cleaned during washing of the patio.
